Wind Mitigation Report

2310 Carrington Ct

Prepared for
Carrington At Stonebridge Condo Association

Uniform Mitigation Verification Inspection Form

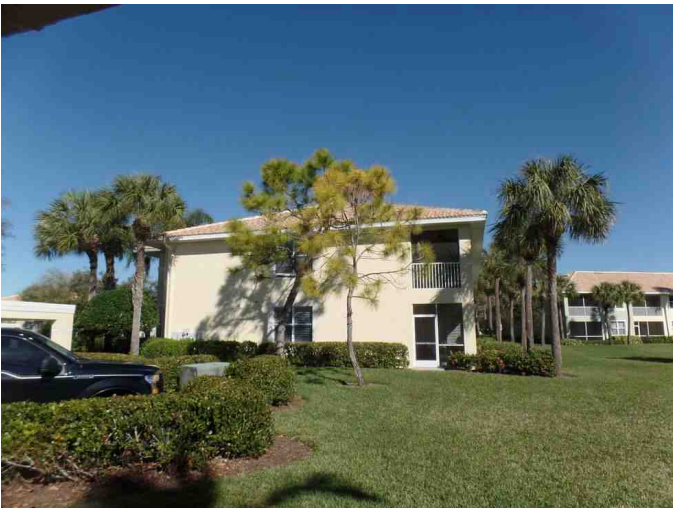
Right Side

- ☒ A. Hip Roof
 - Hip roof with no other roof shapes greater than 10% of the total roof system perimeter.
 - Total length of non-hip features: 0 feet; Total roof system perimeter: 360 feet
- ☐ B. Flat Roof
 - Roof on a building with 5 or more units where at least 90% of the main roof area has a roof slope of less than 2:12. Roof area with slope less than 2:12 _____ sq ft; Total roof area _____ sq ft
- ☐ C. Other Roof
 - Any roof that does not qualify as either (A) or (B) above.

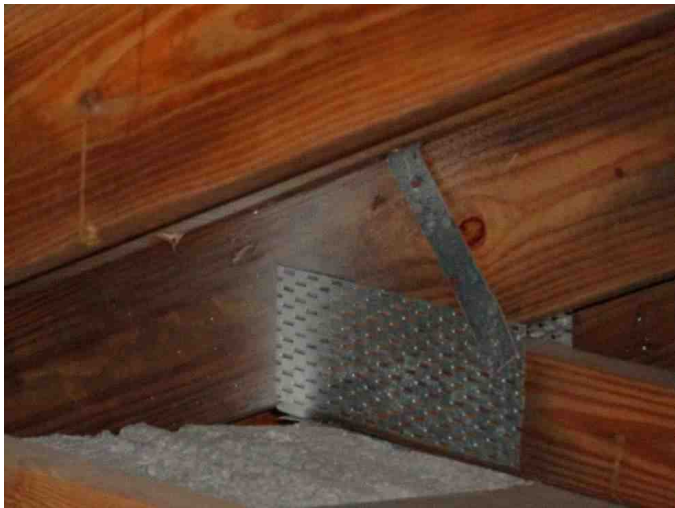
- ☒ Secured to truss/rafter with a minimum of three (3) nails, **and**
- ☒ Attached to the wall top plate of the wall framing, or embedded in the bond beam, with less than a 1/2" gap from the blocking or truss/rafter **and** blocked no more than 1.5" of the truss/rafter, **and** free of visible severe corrosion.

- ☒ C. Single Wraps
 - Metal connectors consisting of a single strap that wraps over the top of the truss/rafter and is secured with a minimum of 2 nails on the front side and a minimum of 1 nail on the opposing side.

Single Wrap

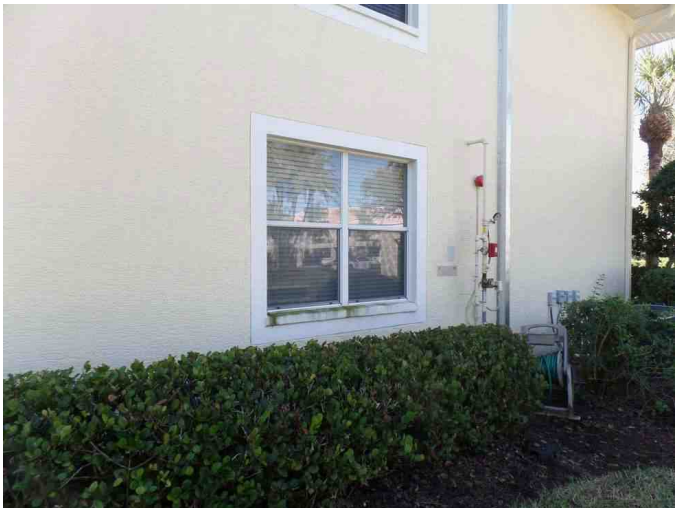
- ☐ **N. Exterior Opening Protection (unverified shutter systems with no documentation)** All Glazed openings are protected with protective coverings not meeting the requirements of Answer "A", "B", or "C" or systems that appear to meet Answer "A" or "B" with no documentation of compliance (Level N in the table above).
- ☐ N.1 All Non-Glazed openings classified as Level A, B, C, or N in the table above, or no Non-Glazed openings exist
- ☐ N.2 One or More Non-Glazed openings classified as Level D in the table above, and no Non-Glazed openings classified as Level X in the table above
- ☐ N.3 One or More Non-Glazed openings is classified as Level X in the table above
- ☒ **X. None or Some Glazed Openings** One or more Glazed openings classified and Level X in the table above.

Unprotected Opening
