Wind Mitigation Report

2350 Carrington Ct

Prepared for
Carrington At Stonebridge Condo Association

Uniform Mitigation Verification Inspection Form

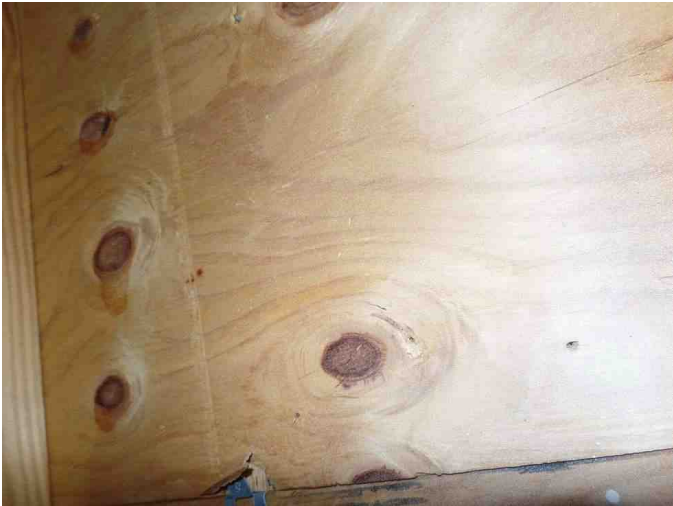
- ☒ C. Plywood/OSB roof sheathing with a minimum thickness of 7/16”inch attached to the roof truss/rafter (spaced a maximum of 24”inches o.c.) by 8d common nails spaced a maximum of 6” inches in the field. -OR- Dimensional lumber/Tongue & Groove decking with a minimum of 2 nails per board (or 1 nail per board if each board is equal to or less than 6 inches in width). -OR- Any system of screws, nails, adhesives, other deck fastening system or truss/rafter spacing that is shown to have an equivalent

Plywood Sheathing

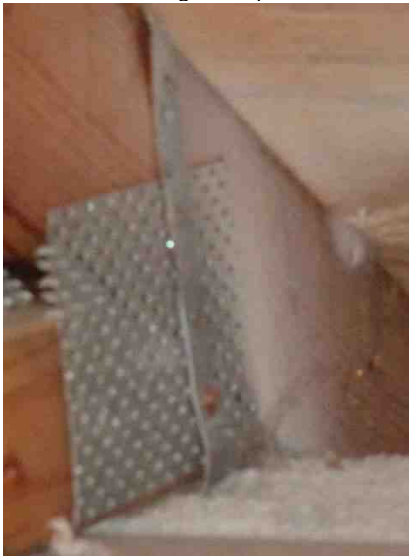
- ☒ C. Single Wraps
 - Metal connectors consisting of a single strap that wraps over the top of the truss/rafter and is secured with a minimum of 2 nails on the front side and a minimum of 1 nail on the opposing side.

Single Wrap

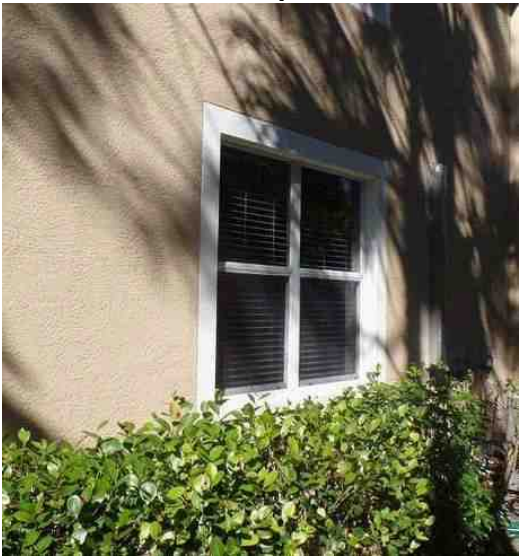
Unprotected Opening
